**Flood Control Project Maintenance
Levee Inspections**
LMA District Cover Sheet
Spring 2018 Levee Inspection Results

Sacramento Maintenance Yard Willow Slough Bypass

Spring 2018 Levee Inspection Results

Levee Inspection Report By Mile - Spring 2018

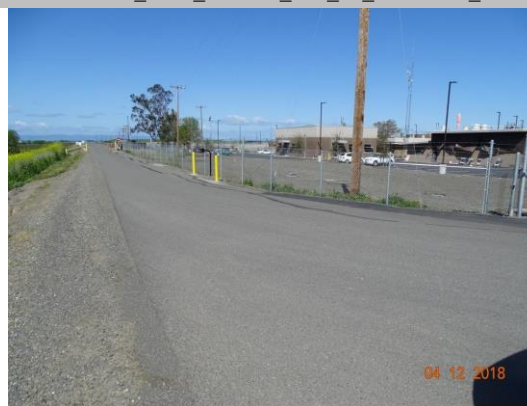
Photo 1 of 1 : SP_2018_ST0012_295_17_20180413_00005.jpg

LM Start	0.00	Rating **	M	Issue No.	17
LM End	0.06	Issue Type +	En	Location *	LS
Category	Earthen Levee			GPS Latitude/Longitude	
				Start	End
Item	Encroachments			38.590772 °	38.590758 °
				-121.665343 °	-121.666370 °
DWR ID	DWR_ST0012_01_s _ 2017_17				
Comment Code					
FE : Fence					
Inspector Comment					
Chain link fence.

View of fence on the landside shoulder. Spring 2018.

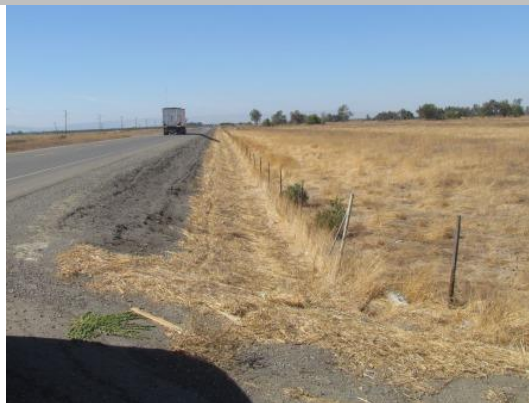
Photo 1 of 1 : SP_2018_ST0012_295_14_20180306_00004.jpg

LM Start	1.53	Rating **	M	Issue No.	14
LM End	2.20	Issue Type +	En	Location *	LS
Category	Earthen Levee			GPS Latitude/Longitude	
				Start	End
Item	Encroachments			38.590334 °	38.590466 °
				-121.693618 °	-121.705849 °
DWR ID	DWR_ST0012_01_f_2016_14				
Comment Code					
FE : Fence					
Inspector Comment					
Barbed wire fence.

View of fence encroaching 10-foot easement on landward side of the levee. Fall 2016.

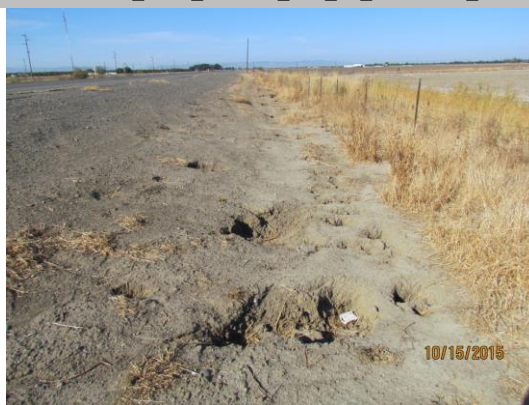
Photo 1 of 1 : SP_2018_ST0012_295_10_20180306_00003.jpg

LM Start	2.93	Rating **	M	Issue No.	10
LM End	3.00	Issue Type +	Ma	Location *	LS
Category	Earthen Levee			GPS Latitude/Longitude	
				Start	End
Item	Erosion / Bank Caving			38.590572 °	38.590653 °
				-121.719349 °	-121.720714 °
DWR ID	DWR_ST0012_01_s_2015_10				
Comment Code					
E1 : Note and monitor erosion site.					
Inspector Comment

View of the erosion on the landward side of the levee looking upstream. Fall 2015.

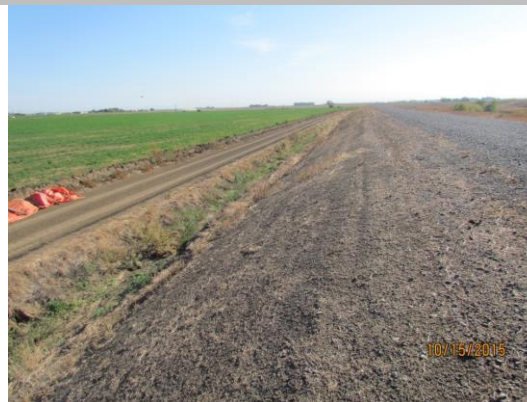
Photo 1 of 1 : SP_2018_ST0012_295_4_20180306_00002.jpg

LM Start	4.12	Rating **	M	Issue No.	4
LM End	4.60	Issue Type +	En	Location *	LS
Category	Earthen Levee			GPS Latitude/Longitude	
				Start	End
Item	Encroachments			38.596784 °	38.599845 °
				-121.737662 °	-121.744830 °
DWR ID	DWR_ST0012_01_s_2012_4				
Comment Code					
DT : Ditch					
Inspector Comment					
Ditch is at the levee toe.

View of the ditch on the landward side of the levee looking downstream.
Fall 2015.

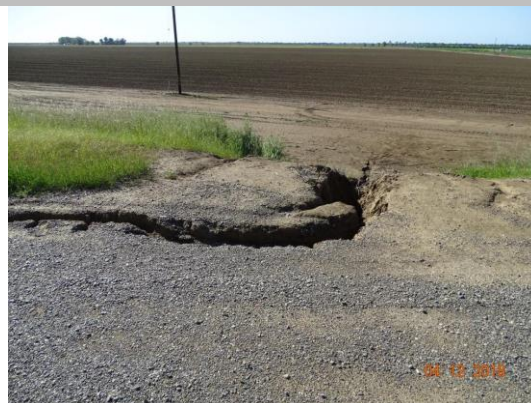
Photo 1 of 2 : SP_2018_ST0012_296_14_20180413_00035.jpg

LM Start	0.03	Rating **	A/W	Issue No.	14
LM End	0.03	Issue Type +	Ma	Location *	LS
Category	Earthen Levee			GPS Latitude/Longitude	
				Start	End
Item	Erosion / Bank Caving			38.598926 °	38.598926 °
				-121.753893 °	-121.753893 °
DWR ID	DWR_ST0012_02_f_2017_14				
Comment Code					
E2 : Schedule repair of erosion site prior to the next inspection.					
Inspector Comment					
Oversized section of levee with approximately 90' crown. Erosion on landside levee berm caused by runoff. Recommend monitoring

Updated view of erosion. Spring 2018.

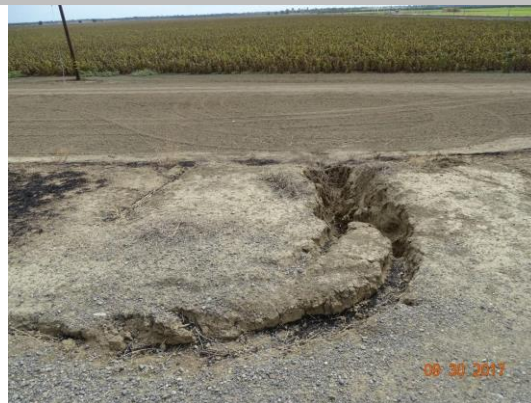
Photo 2 of 2 : SP_2018_ST0012_296_14_20180306_00018.jpg

LM Start	0.03	Rating **	A/W	Issue No.	14 (cont)
LM End	0.03	Issue Type +	Ma	Location *	LS

View of erosion on landside slope. Fall 2017.

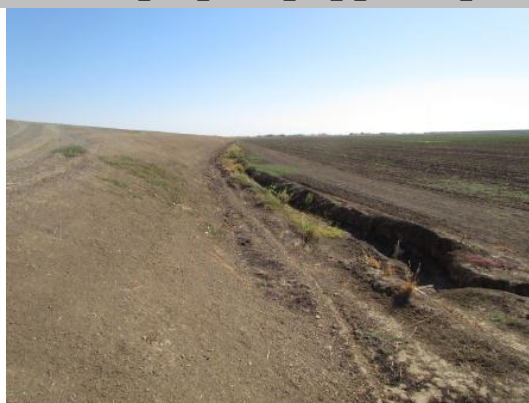
Photo 1 of 2 : SP_2018_ST0012_296_7_20180306_00006.jpg

An updated view of the ditch near LM 0.29. Fall 2016.

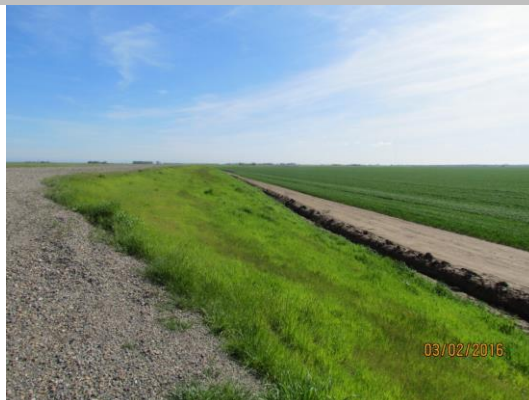
Photo 2 of 2 : SP_2018_ST0012_296_7_20180306_00007.jpg

View of the ditch on the landward side of the levee looking downstream. Spring 2016.

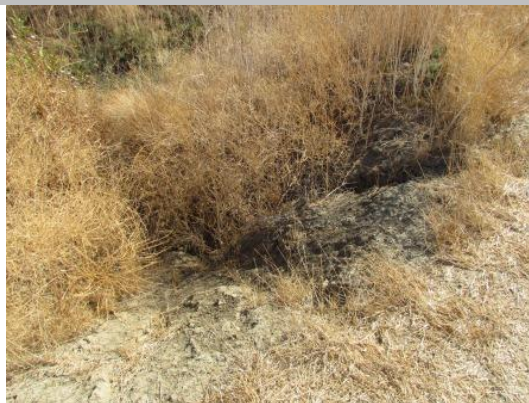
Photo 1 of 1 : SP_2018_ST0012_296_23_20180306_00027.jpg

View of an erosion site around UCIP pipe FSID 13725 on waterward side of the levee. Fall 2016.

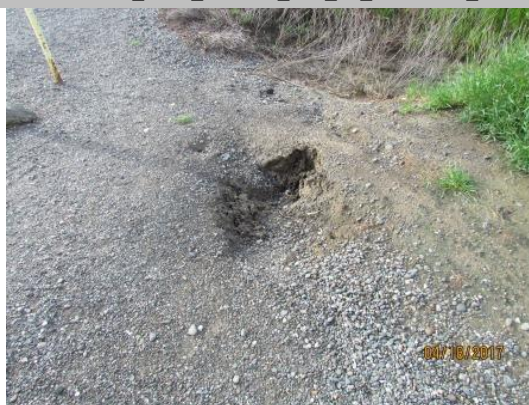
Photo 1 of 1 : SP_2018_ST0012_296_29_20180306_00028.jpg

LM Start	1.57	Rating **	M	Issue No.	29
LM End	1.57	Issue Type +	Ma	Location *	LS
Category	Earthen Levee			GPS Latitude/Longitude	
				Start	End
Item	Slope Stability			38.590064 °	38.590064 °
				-121.730723 °	-121.730723 °
DWR ID	DWR_ST0012_02_s_2017_29				
Comment Code					
S3 : Repair the levee slope damaged by vehicle traffic and prevent access where possible.					
Inspector Comment					
Tire damage on landside levee slope.

View of tire damage on landside levee slope. Spring 2017.

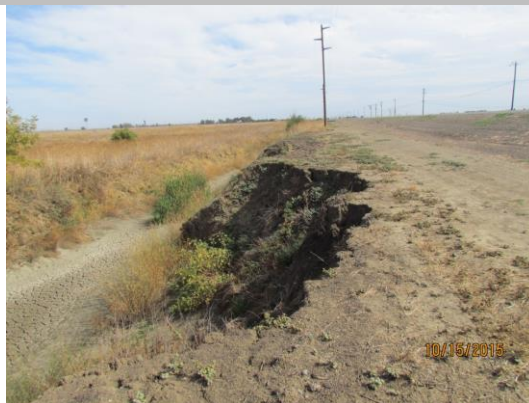
Photo 1 of 1 : SP_2018_ST0012_296_8_20180306_00008.jpg

LM Start	1.77	Rating **	M	Issue No.	8
LM End	1.77	Issue Type +	Ma	Location *	WS
Category	Earthen Levee			GPS Latitude/Longitude	
				Start	End
Item	Erosion / Bank Caving			38.589966 °	38.589966 °
				-121.727072 °	-121.727072 °
DWR ID	DWR_ST0012_02_s_2012_8				
Comment Code					
E1 : Note and monitor erosion site.					
Inspector Comment					
Erosion on waterside stability berm, at the edge of the road. Recommend monitoring.

View of the erosion on the edge of the channel looking downstream. Fall 2015.

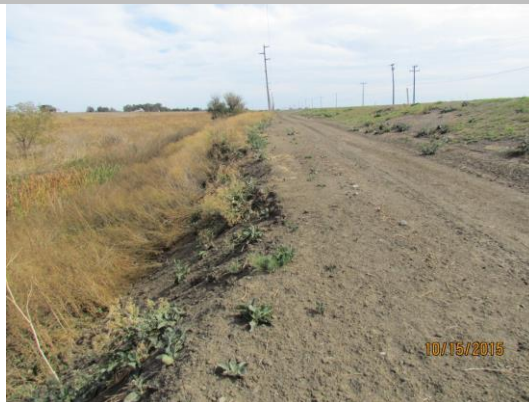
Photo 1 of 2 : SP_2018_ST0012_296_5_20180306_00003.jpg

View of the erosion on the edge of the channel on the waterward side of the levee looking downstream. Fall 2015.

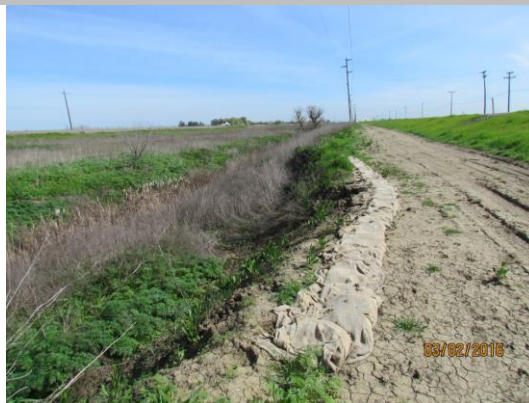
Photo 2 of 2 : SP_2018_ST0012_296_5_20180306_00004.jpg

View of the erosion on the edge of the channel on the waterward side of the levee looking downstream. Spring 2016.

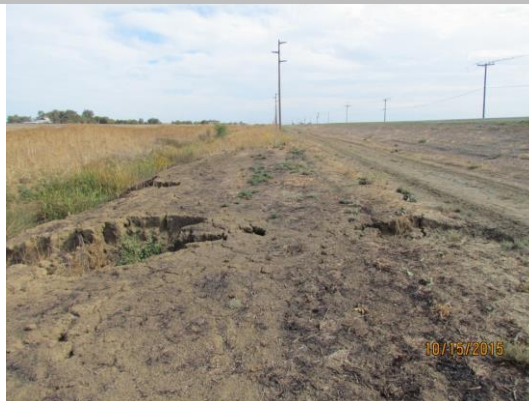
Photo 1 of 2 : SP_2018_ST0012_296_19_20180306_00024.jpg

LM Start	2.25	Rating **	A/W	Issue No.	19
LM End	2.25	Issue Type +	Ma	Location *	WS
Category	Earthen Levee			GPS Latitude/Longitude	
				Start	End
Item	Erosion / Bank Caving			38.589845 °	38.589845 °
				-121.718292 °	-121.718292 °
DWR ID	DWR_ST0012_02_f_2015_19				
Comment Code					
E1 : Note and monitor erosion site.					
Inspector Comment					
Erosion creeping onto toe road.

View of the erosion at the edge of the channel on the waterward side of the levee looking downstream. Fall 2015.

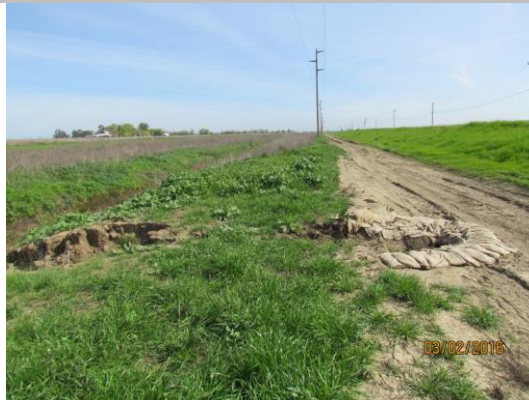
Photo 2 of 2 : SP_2018_ST0012_296_19_20180306_00025.jpg

LM Start	2.25	Rating **	A/W	Issue No.	19 (cont)
LM End	2.25	Issue Type +	Ma	Location *	WS

View of the erosion at the edge of the channel on the waterward side of the levee looking downstream. Spring 2016.

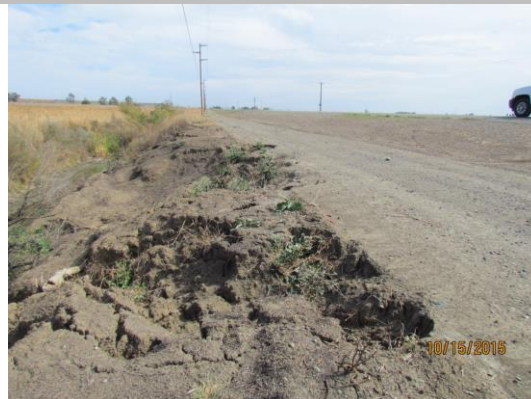
Photo 1 of 1 : SP_2018_ST0012_296_20_20180306_00026.jpg

View of the erosion at the edge of the channel looking downstream. Fall 2015.

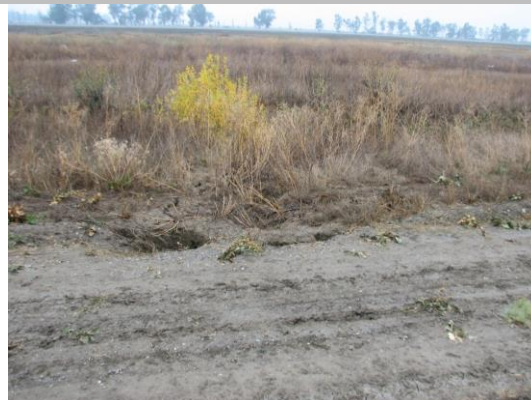
Photo 1 of 2 : SP_2018_ST0012_296_10_20180306_00012.jpg

LM Start	2.82	Rating **	A/W	Issue No.	10
LM End	2.82	Issue Type +	Ma	Location *	WS
Category	Earthen Levee			GPS Latitude/Longitude	
				Start	End
Item	Erosion / Bank Caving			38.589691 °	38.589691 °
				-121.707740 °	-121.707740 °
DWR ID	DWR_ST0012_02_f_2014_10				
Comment Code					
E1 : Note and monitor erosion site.					
Inspector Comment

Erosion on toe road. Fall 2014.

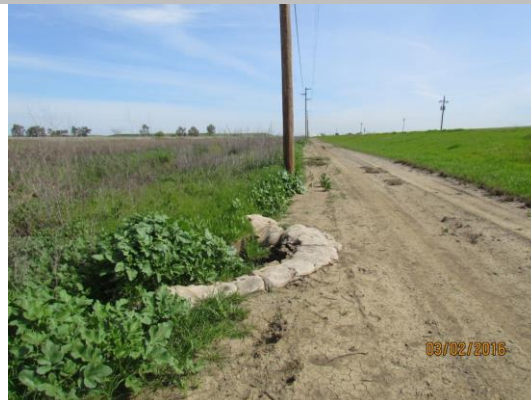
Photo 2 of 2 : SP_2018_ST0012_296_10_20180306_00013.jpg

LM Start	2.82	Rating **	A/W	Issue No.	10 (cont)
LM End	2.82	Issue Type +	Ma	Location *	WS

View of the erosion on the toe road looking downstream. Spring 2016.

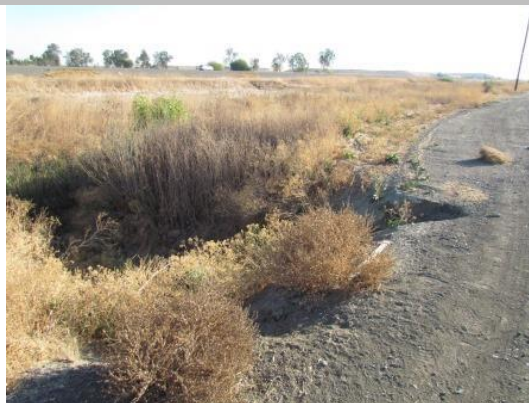
Photo 1 of 3 : SP_2018_ST0012_296_9_20180306_00009.jpg

An updated view of erosion site on waterward side. Fall 2016.

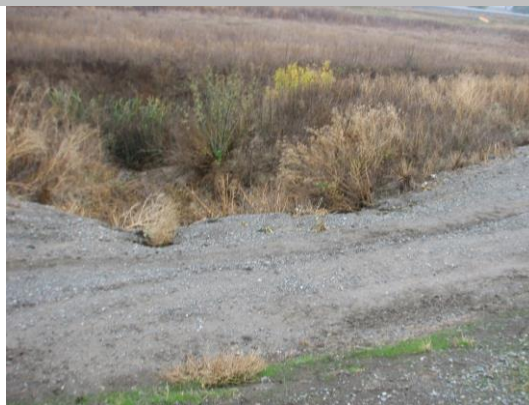
Photo 2 of 3 : SP_2018_ST0012_296_9_20180306_00010.jpg

Erosion on toe road. Fall 2014.

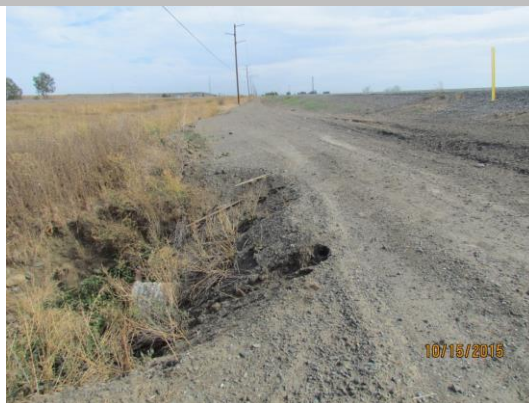
Photo 3 of 3 : SP_2018_ST0012_296_9_20180306_00011.jpg

LM Start	2.97	Rating **	A/W	Issue No.	9 (cont)
LM End	2.97	Issue Type +	Ma	Location *	WS

View of the erosion on the waterward side of the levee looking downstream. Fall 2015.

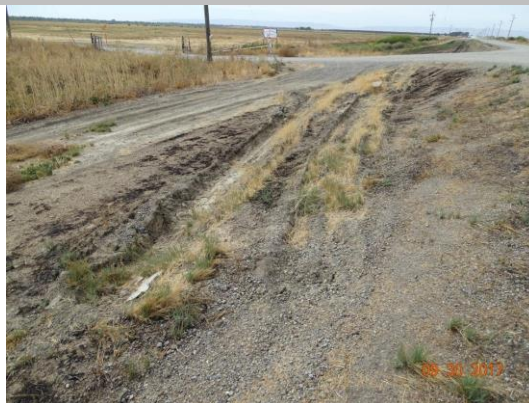
Photo 1 of 1 : SP_2018_ST0012_296_12_20180306_00017.jpg

LM Start	2.98	Rating **	M	Issue No.	12
LM End	2.98	Issue Type +	Ma	Location *	LS
Category	Earthen Levee			GPS Latitude/Longitude	
				Start	End
Item	Slope Stability			38.589673 °	38.589673 °
				-121.704690 °	-121.704690 °
DWR ID	DWR_ST0012_02_f_2017_12				
Comment Code					
S3 : Repair the levee slope damaged by vehicle traffic and prevent access where possible.					
Inspector Comment					
Tire ruts on landside slope.

View of tire ruts on landside slope. Fall 2017.

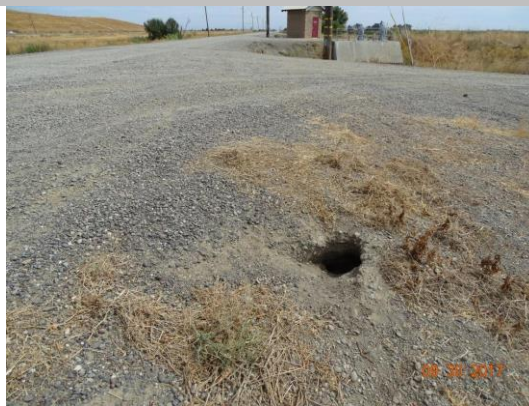
Photo 1 of 1 : SP_2018_ST0012_296_6_20180306_00005.jpg

LM Start	3.60	Rating **	M	Issue No.	6
LM End	3.60	Issue Type +	Ma	Location *	LS
Category	Earthen Levee			GPS Latitude/Longitude	
				Start	End
Item	Animal Control			38.589552 °	38.589552 °
				-121.693408 °	-121.693408 °
DWR ID	DWR_ST0012_02_f_2017_6				
Comment Code					
A3 : No rodents visible, but rodent burrows visible; need to backfill and compact or grout burrows.					
Inspector Comment					
Burrow hole on landside slope near access ramp.

View of burrow hole near access ramp on landside. Fall 2017.

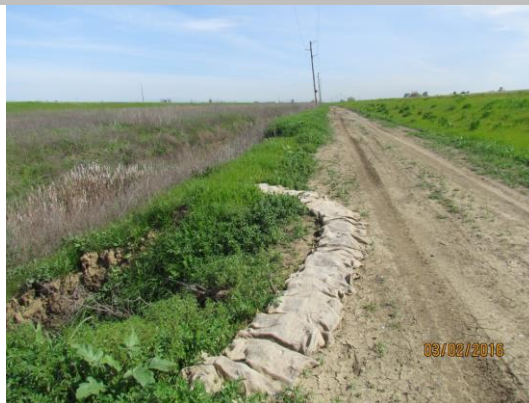
Photo 1 of 1 : SP_2018_ST0012_296_18_20180306_00023.jpg

LM Start	3.95	Rating **	A/W	Issue No.	18
LM End	3.95	Issue Type +	Ma	Location *	WS
Category	Earthen Levee			GPS Latitude/Longitude	
				Start	End
Item	Erosion / Bank Caving			38.589508 °	38.589508 °
				-121.686850 °	-121.686850 °
DWR ID	DWR_ST0012_02_s_2016_18				
Comment Code					
E1 : Note and monitor erosion site.					
Inspector Comment

View of the erosion on the waterward side looking downstream. Spring 2016.

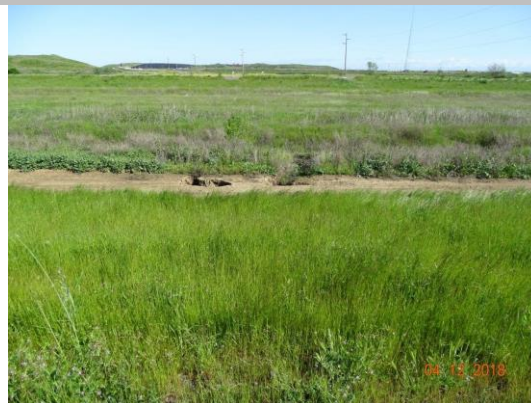
Photo 1 of 1 : SP_2018_ST0012_296_24_20180413_00036.jpg

LM Start	4.09	Rating **	A/W	Issue No.	24
LM End	4.09	Issue Type +	Ma	Location *	WS
Category	Earthen Levee			GPS Latitude/Longitude	
				Start	End
Item	Erosion / Bank Caving			38.589538 °	38.589538 °
				-121.684177 °	-121.684177 °
DWR ID	DWR_ST0012_02_s_2018_24				
Comment Code					
E1 : Note and monitor erosion site.					
Inspector Comment					
Runoff erosion on waterside toe road. Recommend monitoring.

View of erosion on the waterside toe road. Spring 2018.

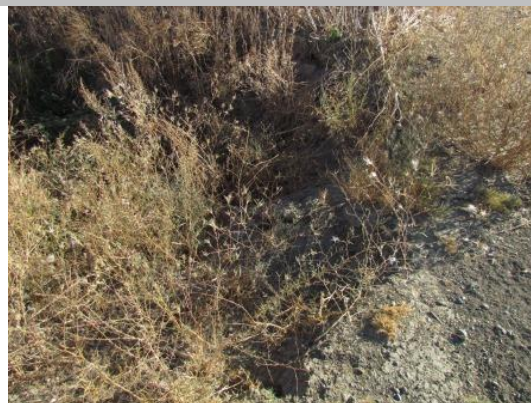
Photo 1 of 3 : SP_2018_ST0012_296_11_20180306_00014.jpg

LM Start	4.29	Rating **	A/W	Issue No.	11
LM End	4.29	Issue Type +	Ma	Location *	WS
Category	Earthen Levee			GPS Latitude/Longitude	
				Start	End
Item	Erosion / Bank Caving			38.589550 °	38.589550 °
				-121.680632 °	-121.680632 °
DWR ID	DWR_ST0012_02_f_2014_11				
Comment Code					
E1 : Note and monitor erosion site.					
Inspector Comment					
Erosion is near waterside toe on waterside berm at storm drain. Recommend monitoring.

An updated view of the erosion site near the WS levee slope. Fall 2016.

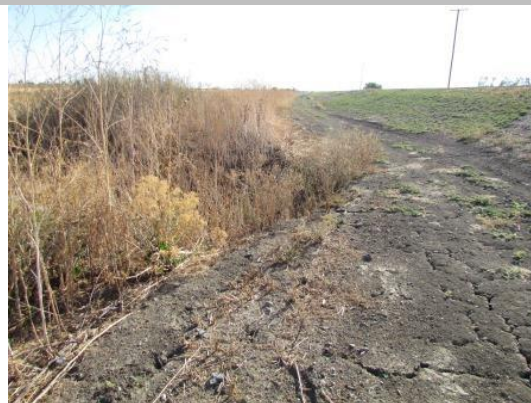
Photo 2 of 3 : SP_2018_ST0012_296_11_20180306_00015.jpg

LM Start	4.29	Rating **	A/W	Issue No.	11 (cont)
LM End	4.29	Issue Type +	Ma	Location *	WS

Perspective view of the site. Fall 2016.

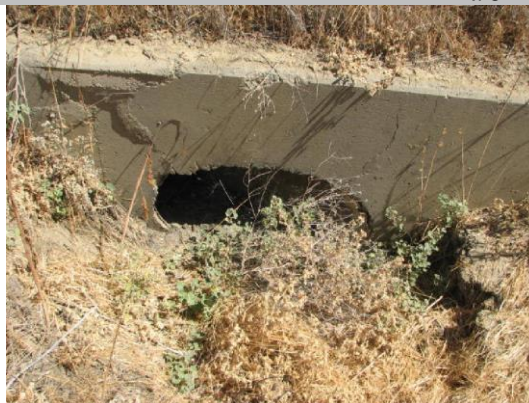
Photo 2 of 3 : UCIP_SP_2018_45285_22811.jpg

Comment Code						
Inspector Comment						
FS_ID:45285 DS_ID:546 EP_NO: 10319 Repair Type: Non-Urgent Crossing Status: Found UCIP Comments: 04/12/2017 WS & LS - good/clear, inspected by JK, RF. (DWR Sacramento Yard - C. Lund) 05/24/2013 Material removed from inlet last fall. Outlet cleared. (DWR Sacramento Yard - C. Lund) 09/20/2012 Soil and debris on inlet mouth. (DWR UCIP - P. Amatya) FIELD_STRUCT_DESC: 24-inch corrugated metal drainage pipe through the levee, 15 feet below the crown. Flap gate is located on the waterside (WS) end. (18-inch pipe [HLM 4.52] authorized under Automatic Board Order (ABO) issued as Permit No. 10319, 1974 - Bell) [Additional Reference(s): DWR Levee Log, 1990. USACE Sacramento O&M Manual Unit 120, Willow Slough Channel Relocation and Levee Construction, February 1947, Drawing No. 50-4-2281 Sheet 4 (Station 244+47)] FS Date: 5/14/2015 1:36:11 PM

Landside view- pipe and headwall.

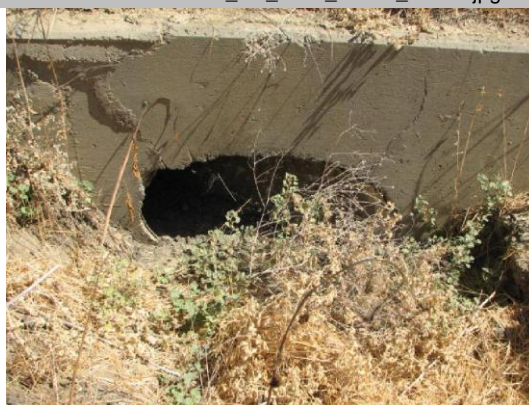
Photo 3 of 3 : UCIP_SP_2018_45285_22810.jpg

Landside view- soil and debris on mouth of the inlet pipe.

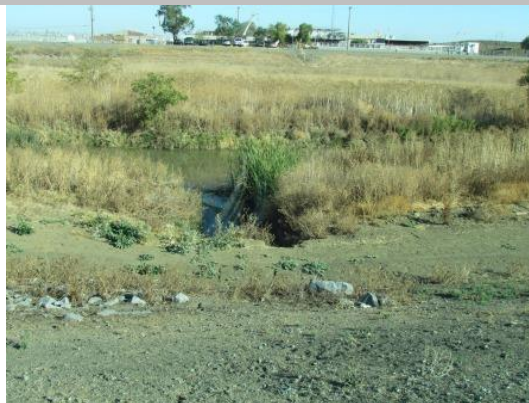
Photo 1 of 3 : SP_2018_ST0012_296_15_20180306_00019.jpg

LM Start	5.05	Rating **	A/W	Issue No.	15
LM End	5.05	Issue Type +	Ma	Location *	WS
Category	Earthen Levee			GPS Latitude/Longitude	
				Start	End
Item	Erosion / Bank Caving			38.589570 °	38.589570 °
				-121.666588 °	-121.666588 °
DWR ID	DWR_ST0012_02_s_2015_15				
Comment Code					
E1 : Note and monitor erosion site.					
Inspector Comment					
Erosion near levee toe on waterside berm at storm drain. Recommend monitoring.

An updated view of the erosion site near the levee slope. Fall 2016.

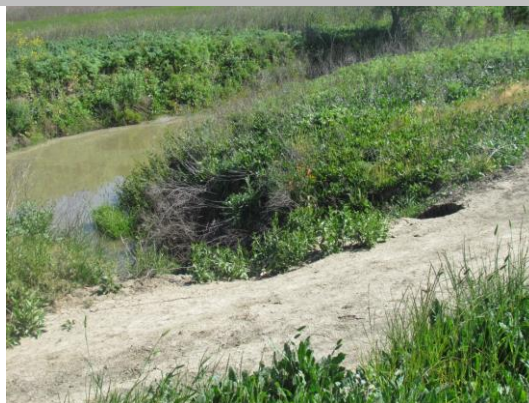
Photo 2 of 3 : SP_2018_ST0012_296_15_20180306_00020.jpg

View of the erosion on the edge of the channel on the waterward side of the levee. Spring 2015.

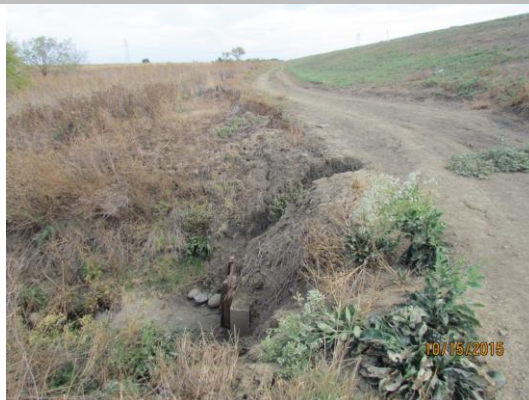
Photo 3 of 3 : SP_2018_ST0012_296_15_20180306_00021.jpg

LM Start	5.05	Rating **	A/W	Issue No.	15 (cont)
LM End	5.05	Issue Type +	Ma	Location *	WS

View of the erosion at the edge of the channel on the waterward side of the levee looking downstream. Fall 2015.

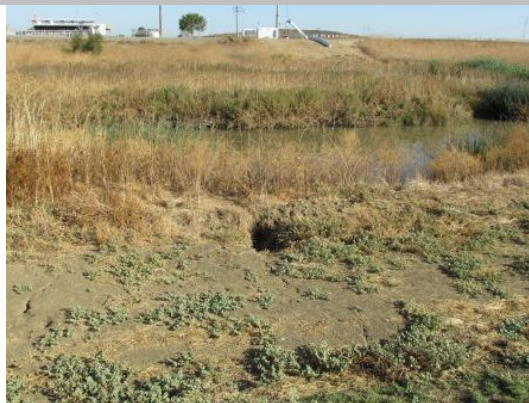
Photo 1 of 1 : SP_2018_ST0012_296_17_20180306_00022.jpg

View of a site that may become a larger erosion site in the future.
Waterward side of the levee looking downstream. Fall 2016.
